# **Completion Report**

**Cold Water Storage Tank**

Hull

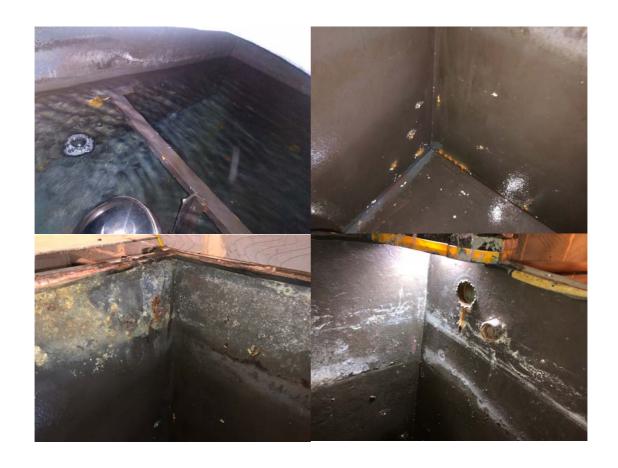
The cold water storage tank was previously coated 15 years ago with an epoxy coating which had subsequently failed, exposing the corroded surface beneath subsequently causing the tanks internal surfaces to rapidly deteriorate.

**BEFORE** – CWST heavily affected by internal rusting.
