## MARINE CASE STUDY

**Vessel:** Maersk Connector. 2016 Latest Generation Cable Layer. 10,000 Tons

**System:** HPU Cooling water pipes.

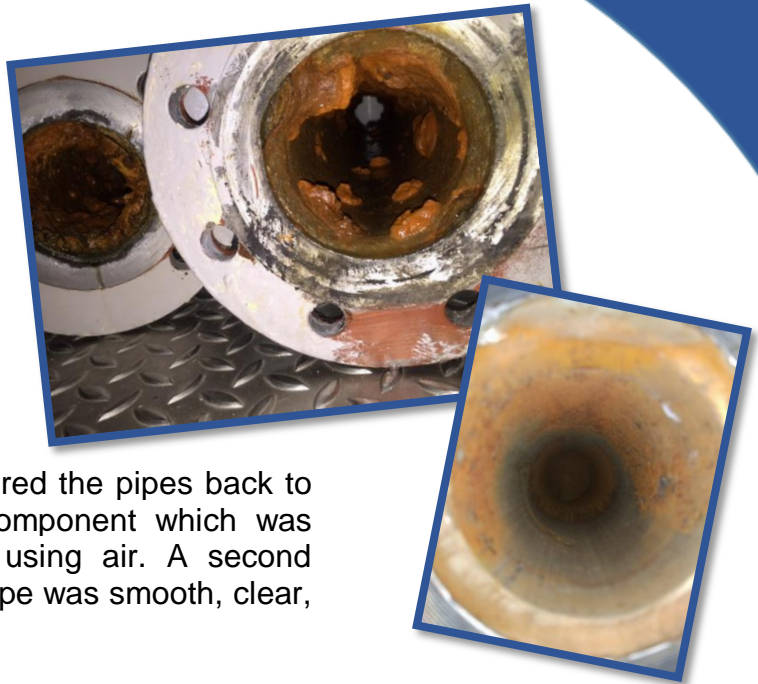
**Solution:** R2 Pipetech's highly skilled technicians were able to solve this problem for the customer without causing any damage to the Ship. Firstly the team inspected the condition of the corroded pipes and assessed the nature of the problem. Borescope pictures revealed areas of the pipe with pitting and through-wall corrosion.

The R2 Pipetech team cleaned and restored the pipes back to their original state using an abrasive component which was shot-blasted through the entire system using air. A second inspection was conducted to ensure the pipe was smooth, clear, and ready for the liner to be installed.

R2 Pipetech's unique lining Epoxy was used to line the HPU Cooling system. The liquid Epoxy was blown through the system to evenly coat the walls of the pipes, forming a smooth barrier between the pipe and water. This barrier coating was then cured before final inspection confirmed that the system was restored to the highest standard of quality.
