Report following lining of Fire suppression pipes on M/Y Dynasty

Prepared by Hugh Cullen
Technical Manager
R2 Pipetech Ltd
v1.0
Feb 2020

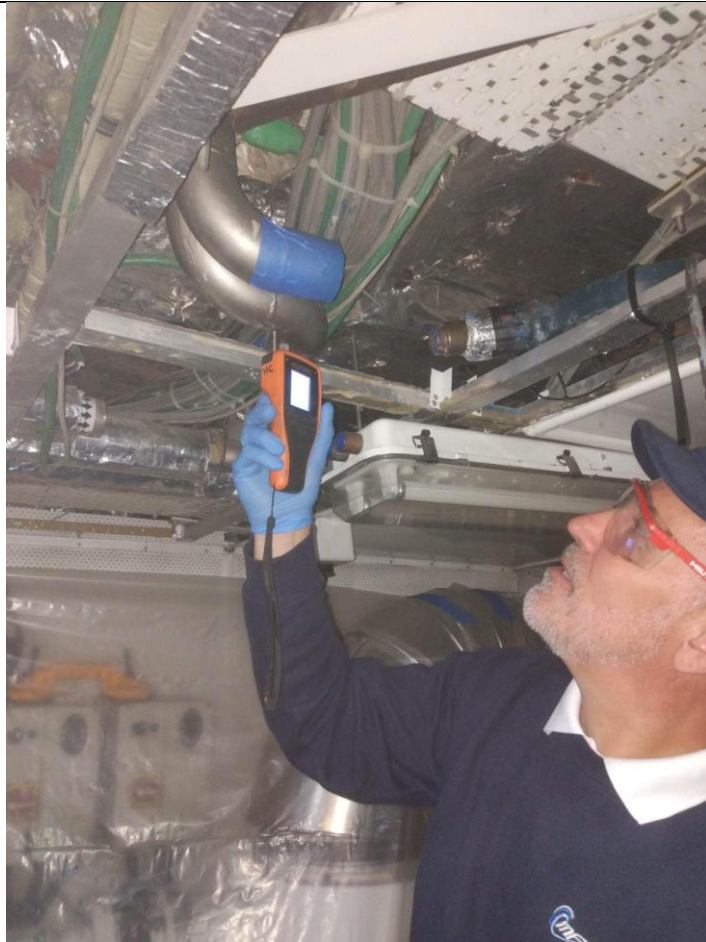
Pipe access was good in the ceiling of the engine room

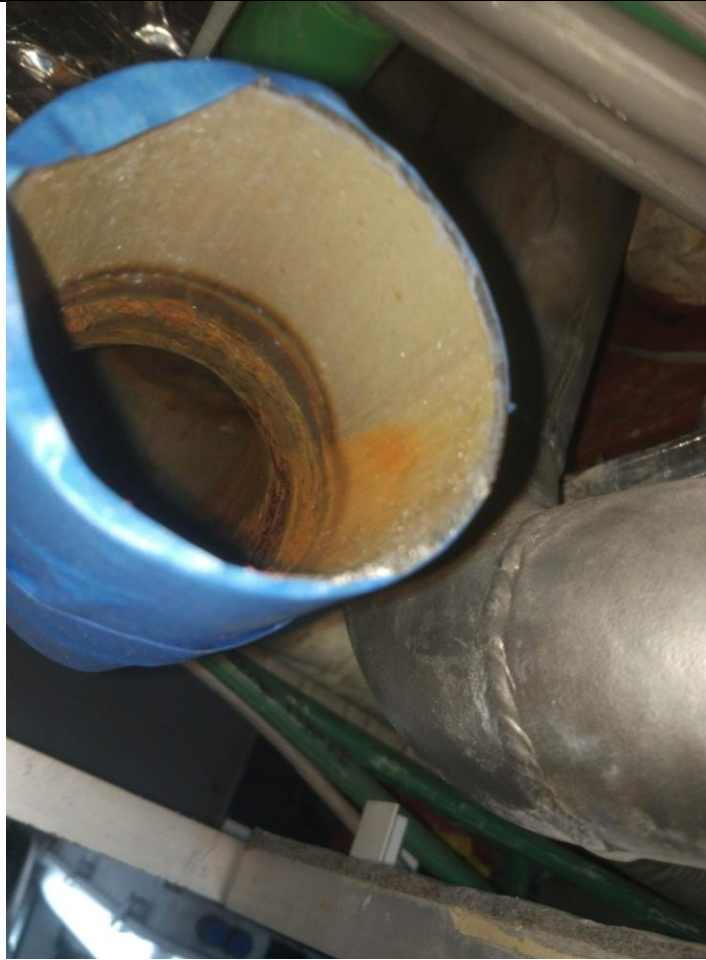
50mm Pipe Showing internal corrosion in the welds

R2 Pipetech technicians were able to solve this problem for the customer without causing any damage to the vessel . Firstly the team inspected the condition of the corroded pipes and assessed the nature of the problem. Broscope camera inspection revealed corrosion on the welded joints and possible leaking points on the butted joints

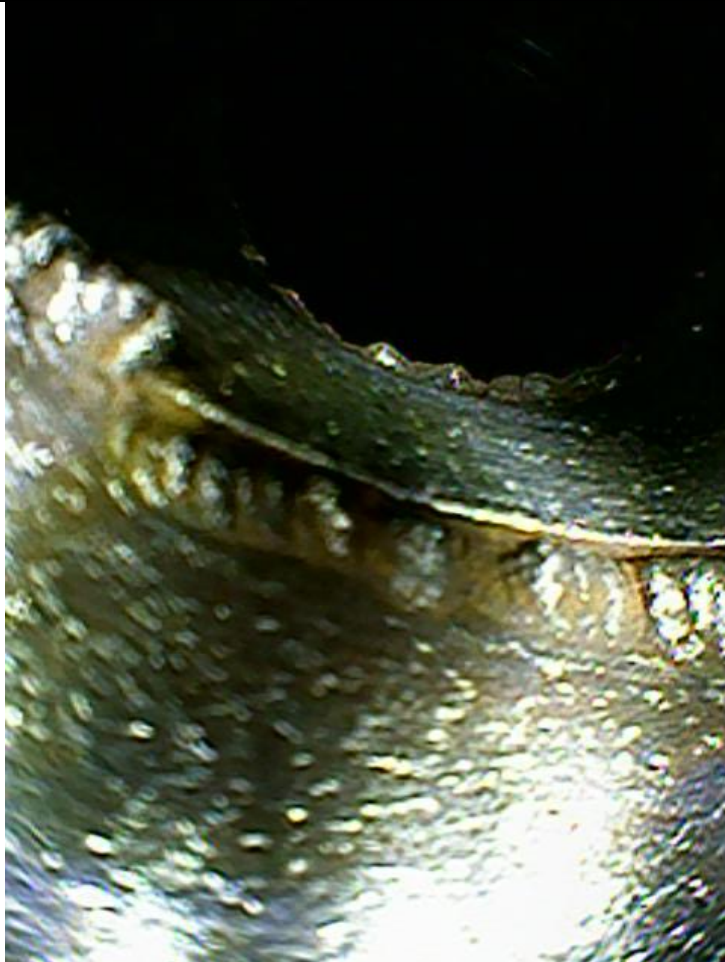
Potential point of leakage at butt joint

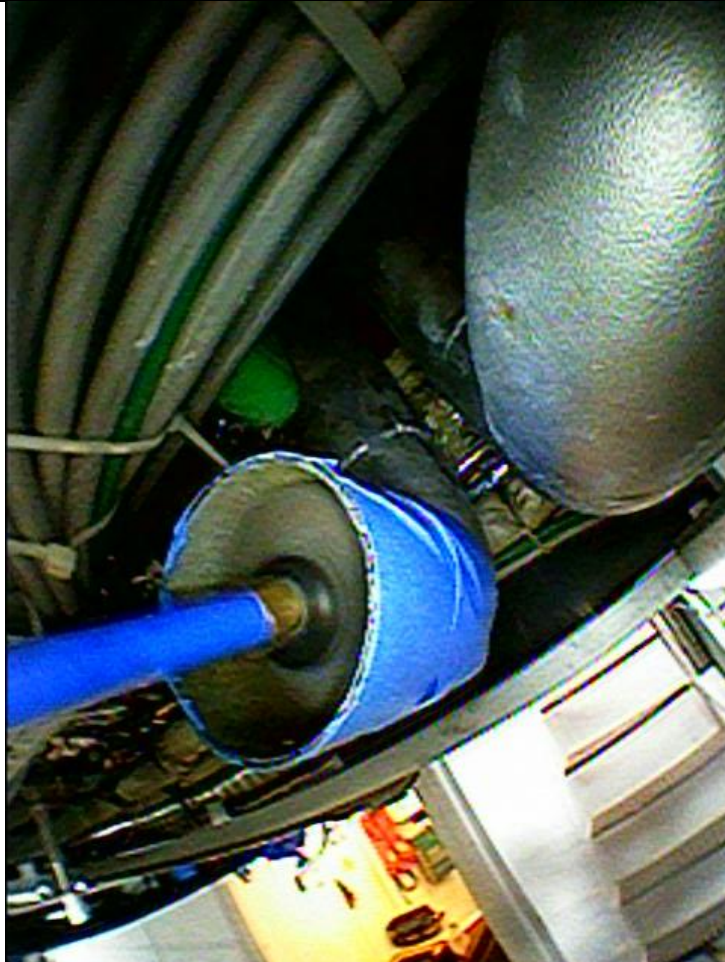
Mechanically cleaning the Pipe

The team cleaned and restored the pipes state using abrasive tools which removed the corrosion and scale and created a surface profile for the lining to adhere. A second inspection was conducted to ensure the pipe was prepared, clear, and ready for the liner to be installed.

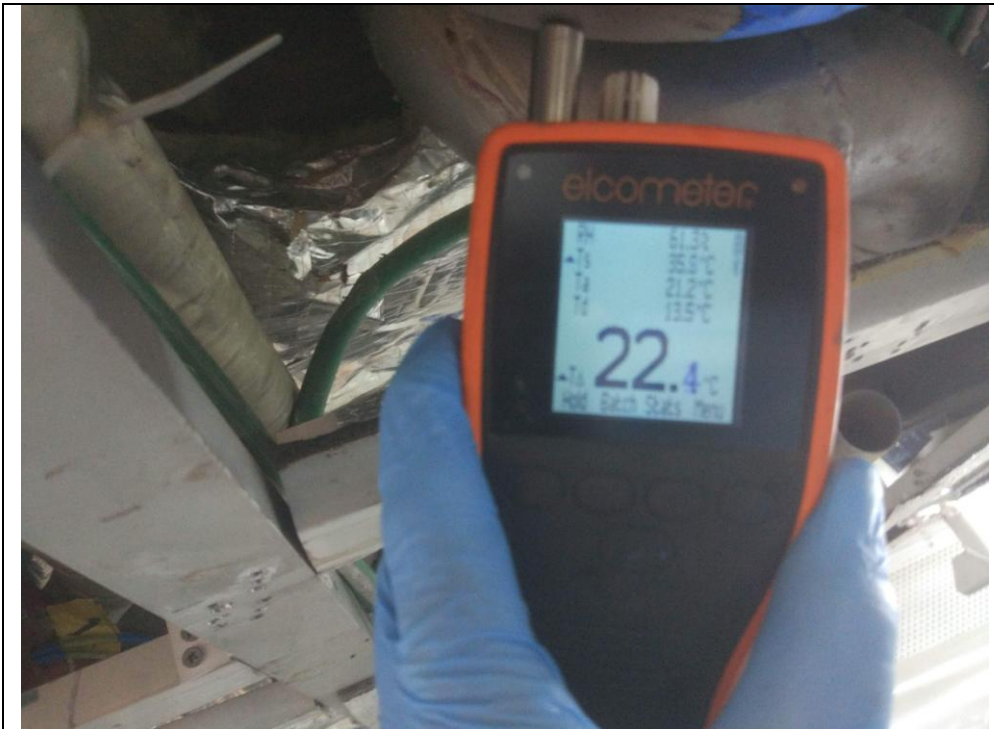
Temperatures and dew point all within acceptable limits

Following the Cleaning procedure, the pipes were then heated ensure no moisture remained in the area and ensure the humidity levels are within the parameters to accept the coating. The Coating material was conditioned and dispensed ready for mixing.

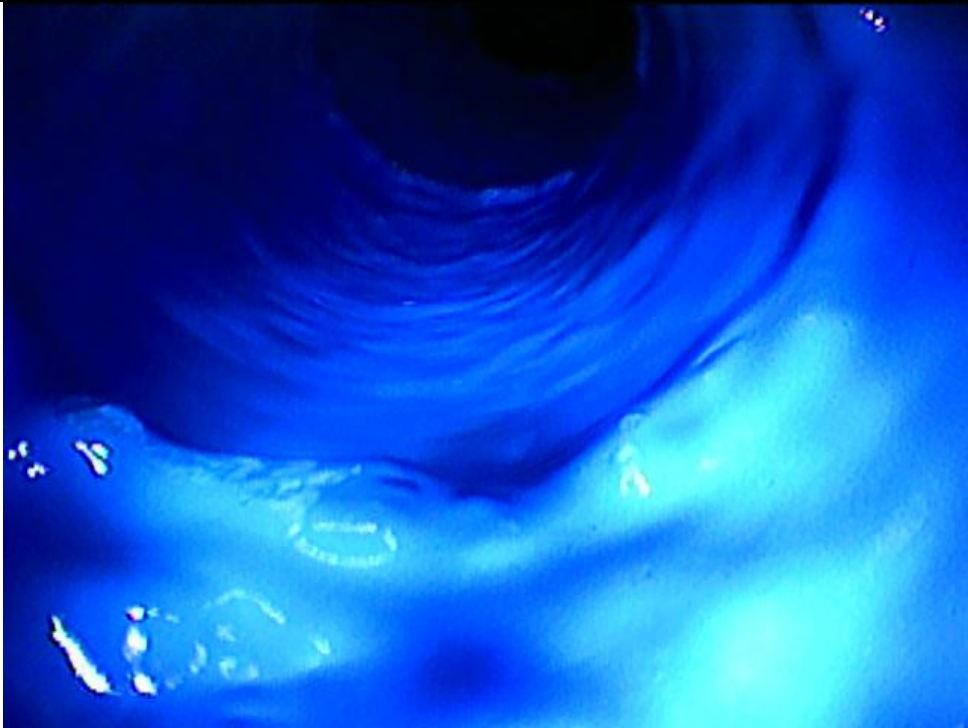
Each of the pipes were inspected using the borescope after allowing the epoxy to cure overnight. Each inspection found the condition of the epoxy resin lining satisfactory. The welded joints were fully overcoated in the areas suspected of pitting. Three coats were applied to each pipe to ensure full coverage in the areas suspected of leaking.

Welded joint showing good monolithic coverage

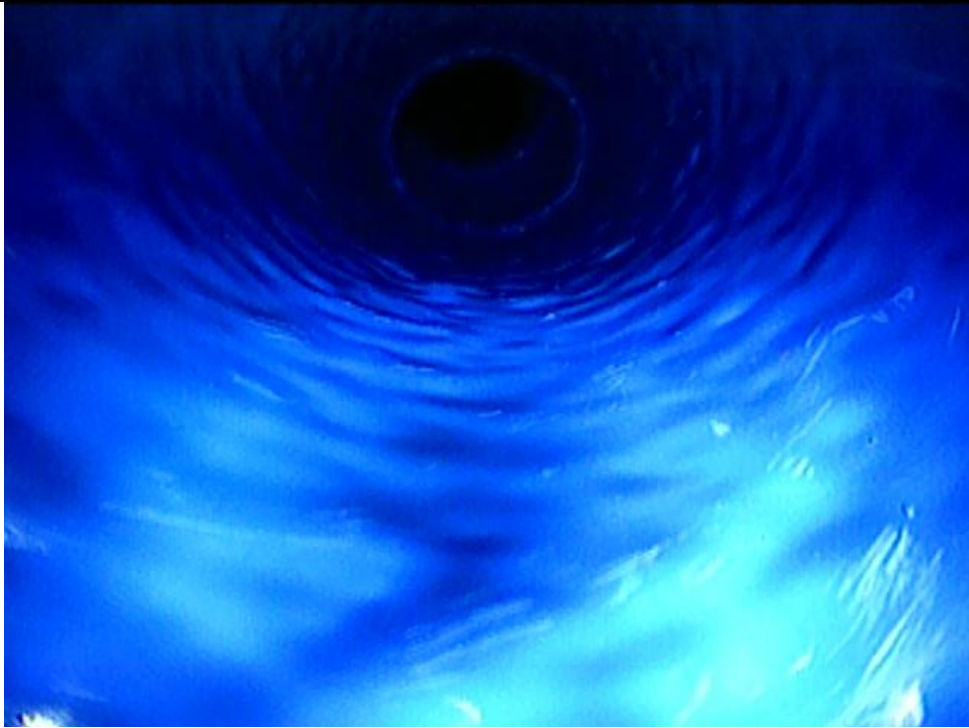
Post Lining Boroscope picture
