Completion Report

Buckingham Palace

Project Brief

Cold water storage tank P5 – Core C

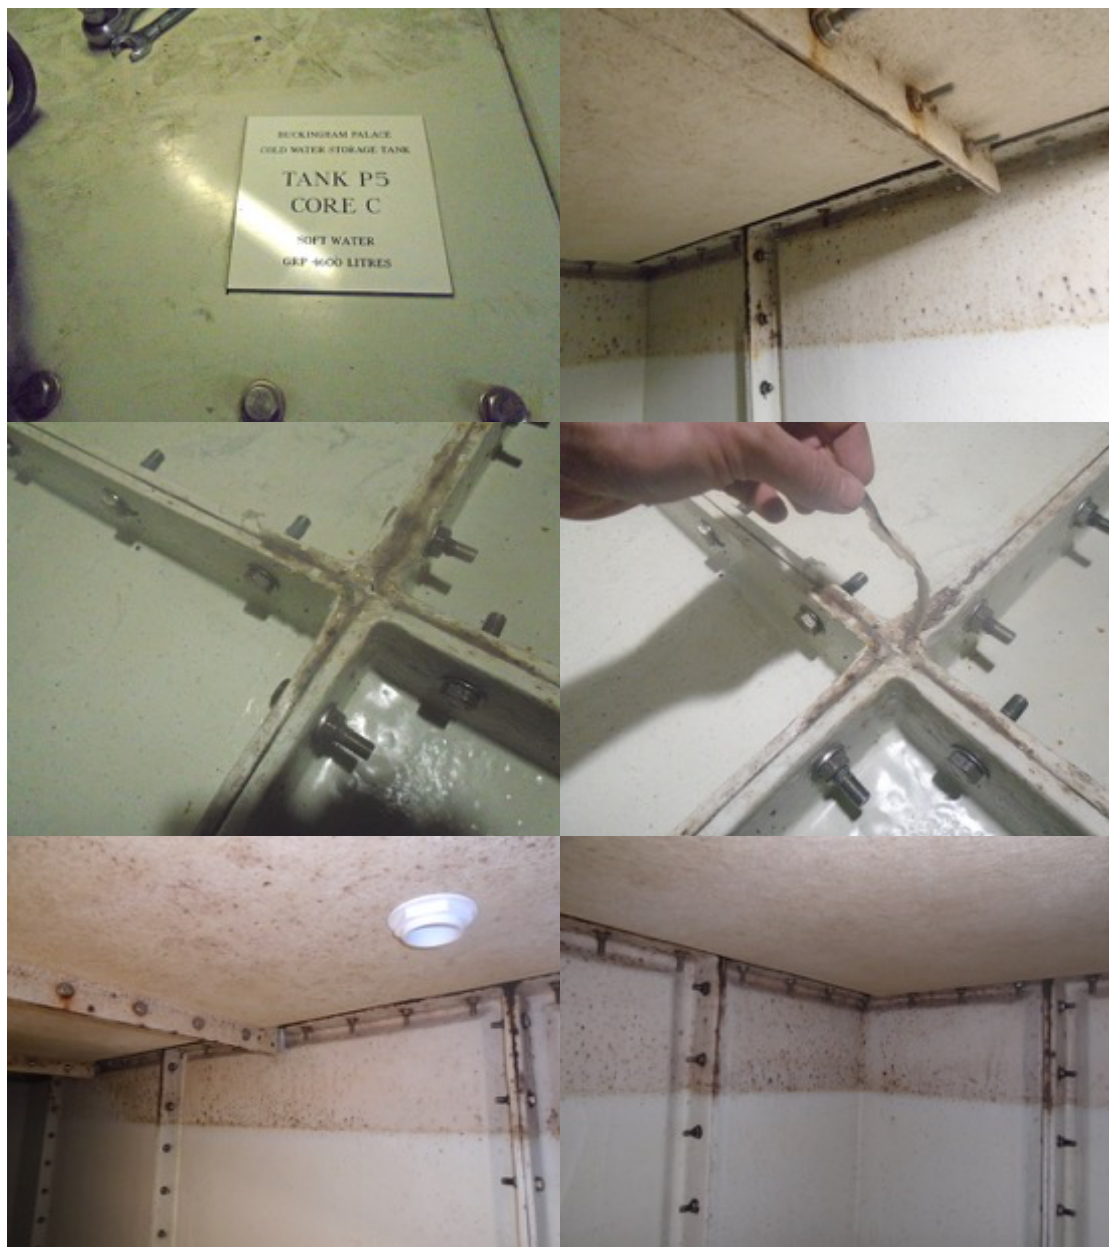
BEFORE – The tank was in fair condition but the butyl sealant had started to deteriorate and there was evidence of osmotic blistering and black mould spore growth which was particularly bad above the water line.
