MARINE PIPE RELINING CASE STUDY

Customer: Military Vessel

System: Fire suppression system, 150mm (6") – 200mm (8") diameter pipes, suffering from pitting and corrosion attributed to Electrolysis

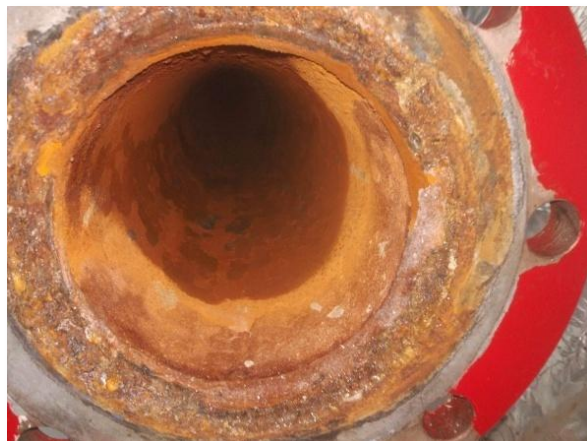
Corrosion has led to through-wall corrosion, wall thickness loss and leaks in many of the various pipes throughout the vessel.

Solution: The pipes were opened at the nearest available locations, the system was drained and dried and then inspected with specialist inspection cameras to ascertain the condition of the pipe interior

The pipes were cleaned and blasted to create the blast profile required for the protective coating.

Once cleaned and dried the pipe is heated to and conditioned for the coating to be applied.

In this instance, 3 coats were applied to achieve the specified DFT.

A final pressure test and camera inspection revealed a successful repair, new valves were installed and the system was pressure tested and recommissioned

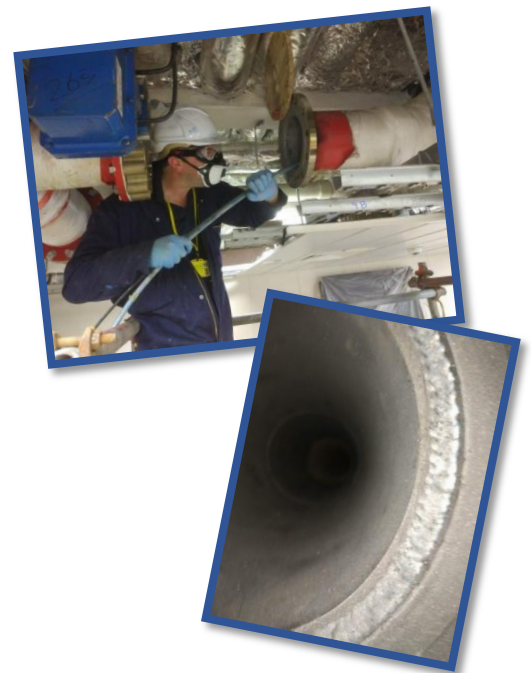
This pipe is returned to service and is now protected from any further deterioration..
