## MARINE CASE STUDY

**Vessel:** Maersk Connector. 2016 Latest Generation Cable Layer. 10,000 Tons

**System:** HPU Cooling water pipes.

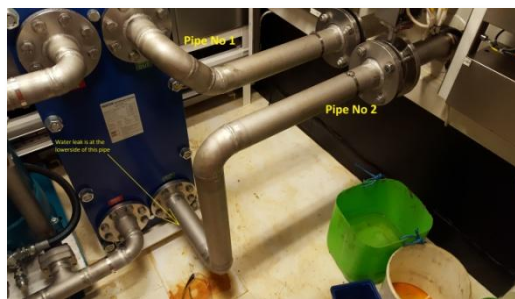
2.5" 316 Stainless steel

**Problem:** Cooling Pipes supplying the Hydraulic power unit was suffering from internal corrosion resulting in leaks and loss of performance. This vessel operates on a tight schedule, time for repair was limited.

**Solution:** R2 Pipetech's highly skilled technicians were able to solve this problem for the customer without causing any damage to the Ship. Firstly the team inspected the condition of the corroded pipes and assessed the nature of the problem. Borescope pictures revealed areas of the pipe with pitting and through-wall corrosion.

The R2 Pipetech team cleaned and restored the pipes back to their original state using an abrasive component which was shot-blasted through the entire system using air. A second inspection was conducted to ensure the pipe was smooth, clear, and ready for the liner to be installed.

R2 Pipetech's unique lining Epoxy was used to line the HPU Cooling system. The liquid Epoxy was blown through the system to evenly coat the walls of the pipes, forming a smooth barrier between the pipe and water. This barrier coating was then cured before final inspection confirmed that the system was restored to the highest standard of quality.
